AKÜ FEMÜBİD 18 (2018) 015604 (285-294)

Seismic Vulnerability Assessment of Reinforced Concrete Buildings Located in Esenler District of İstanbul

Hasan Özkaynak¹, Ayşe Elif Özsoy Özbay²^{1,2} Beykent Üniversitesi, Mühendislik-Mimarlık Fakültesi, İnşaat Mühendisliği Bölümü, İstanbul.e-posta: ¹hasanozkaynak@beykent.edu.tr, ²elifo@beykent.edu.tr

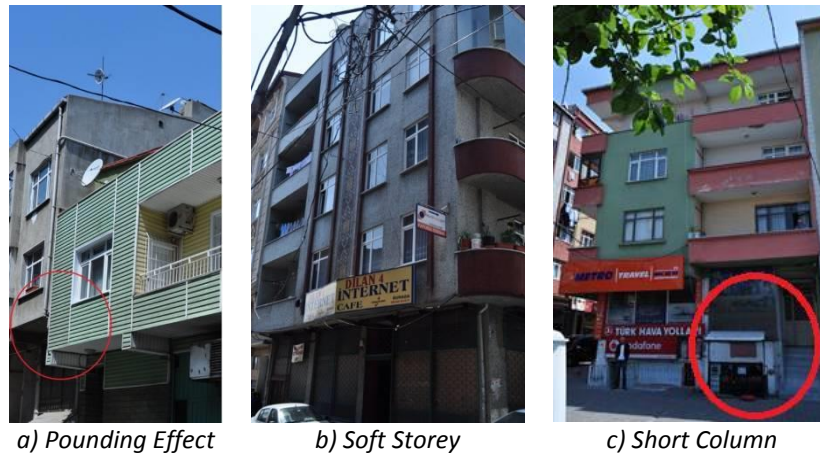
Figure 2. Some observations related with pounding effect, soft story, and short column

5. *Short column effects*: This effect exists for the buildings which have half height infill walls and mid-story beams which cause probable shear failures, Fig.2c.

6. *Pounding effects*: This effect could be observed for the adjacent structures which have colliding risk during earthquakes, Fig.2a.

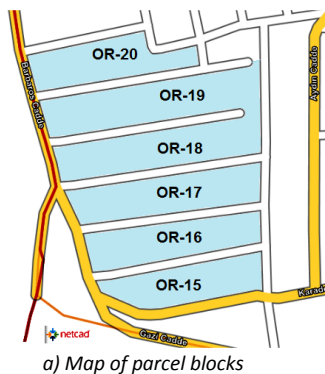
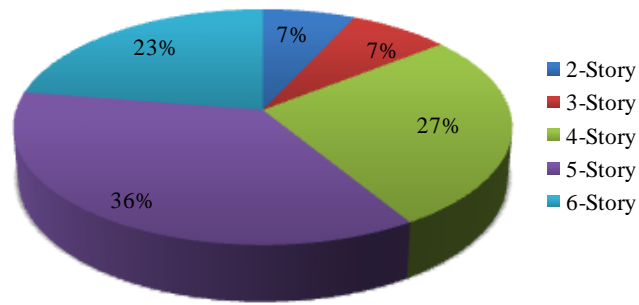
Figure 4. Parcel blocks of surveyed region

between successive parcel-blocks are located parallel to each other providing a regular geometric surveying field for the screeners, Fig.4. The distribution of the buildings in percentage with 5 and 6 story heights are 36% and 23% respectively.

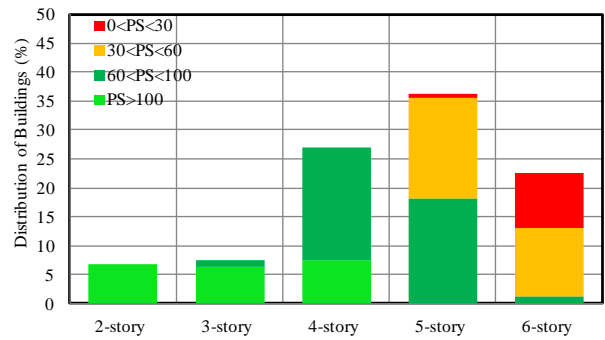
Figure 5. Distribution of buildings in terms of storey numbers and performance scores.

The performance score of each building is predominantly affected by the height of the building. It is clearly seen from Fig.5 that, the buildings having 2-storey, 3-storey and 4-storey

heights are almost the 21% of selected building stock with the range of $PS > 100$. However, the group of buildings having 5 to 6 storey heights consists of 18% and 12% of the building stock respectively with the range of $30 < PS \leq 60$. Moreover, 9% of the building stock with 6 storey height falls into range of $0 < PS \leq 30$. It should be noted that as the buildings get higher, the PS values considerably decreases. The low to mid-rise buildings fall into safer range of $PS > 100$. Thus, the priority ordering for detailed assessment should start with the higher risk group of buildings with the relatively lower PS range ($0 < PS \leq 30$).

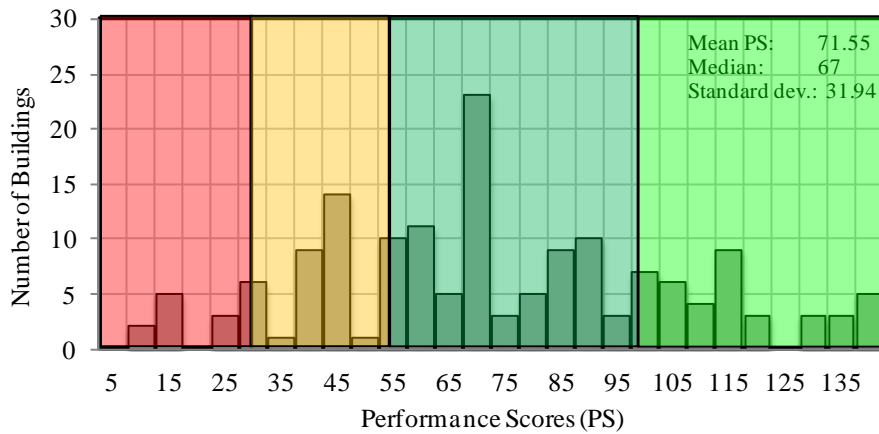
Figure 6. The histogram chart for obtained performance scores

The seismic risk assessment method described above is employed to the selected building stock and the obtained performance scores as given in histogram format in Fig.6.

The histogram which is given in Fig. 6 shows the distribution of the building dataset with respect to performance scores obtained from the surveying. The mean value of the performance scores for the building stock has been calculated as 71.55 with a standard deviation of 31.94. Since the standard deviation value for the dataset is 32, the general profile of the building stock could be represented by the range of $60 < PS \leq 100$ which corresponds to the

moderate priority level. The number of the buildings which fall into the range of $PS > 100$ is greater than the number of the buildings fall into the range of $30 < PS \leq 60$. The distribution clearly shows that 10% of the surveyed buildings have performance scores lower than 30 ($0 \leq PS \leq 30$), which means these buildings have the highest priority for detailed intervention and seismic assessment.

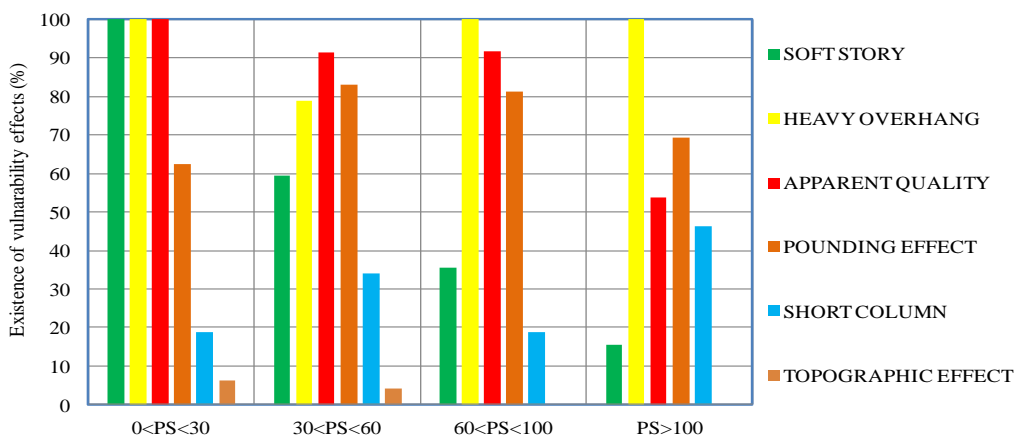
Figure 7. The distribution of buildings considering the existence of the vulnerability parameter within the priority ranges

The existence of vulnerability effects on the performance scores are given in Fig. 7. This figure yields the graphical representation for the distribution of buildings according to the existence of the vulnerability parameter for each PS range. The number of buildings with topographic effect is almost negligible whereas heavy overhang is a

common characteristic for all of the buildings at each priority level.
